Installing the Flyinmiata Link Intake Air Temperature sensor into a supercharged MX5

Jeremy Hendy, 11th August 2001

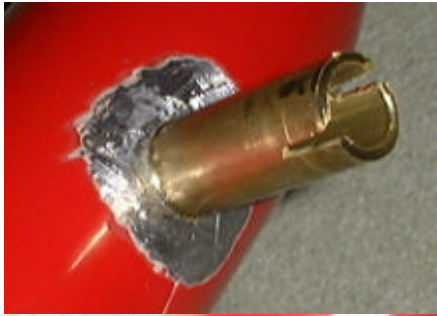
As you can see in the picture, I used the Dremel with a grinding attachment to take off the powder coating from the crossover tube for about 1cm around the hole.

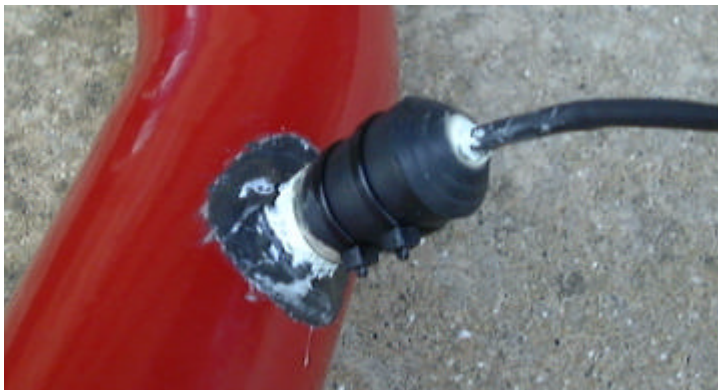
My first attempt routed the two wires back down the side of the tube to avoid piercing the cap. A tie-wrap was then used to stop the cap flying off under boost. In the photo, you can also see the 2-way connector that I used to connect the sensor to the wiring harness – as the crossover tube seems to get regularly removed, I wanted to be able to easily connect and disconnect the temperature sensor.

Having fitted the pipe, I found it difficult to get a stable idle (although the idle MAP readings were pretty much the same as before, the IAC% was close to zero. Interestingly enough, boost wasn't significantly affected. I suspected an air leak down the side of the pipe, where the wires exited the cap.

For leak-testing the pipe, I re-fitted the silicone hoses at either end of the pipe, clamped the cap from a large aerosol in one end to provide a seal, and in the other end I clamped a round plastic water bottle with a hole drilled in the bottom of it. Squeezing the bottle then pressurised the crossover pipe – sure enough, you

could hear the hiss as the air escaped past the wires.

I subsequently pierced the end of the rubber cap, pushed the wires through (having previously tied a knot in them, as per the FM instructions), and (messily!) sealed the hole with silicone sealant – this worked fine.
