Installing the Flyinmiata Link Intake Air Temperature sensor into a supercharged MX5

Jeremy Hendy, 11th August 2001

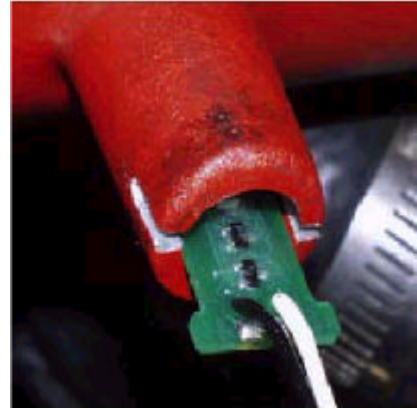
The air intake temperature sensor is a small printed circuit board, around 44mm x 12.5mm, which is designed to be mounted inside the idle air hose stub pipe of the FlyinMiata turbos – see the picture on the right & the installation instructions at <http://www.dlralt.com/intakeairtemp.pdf> for more details.

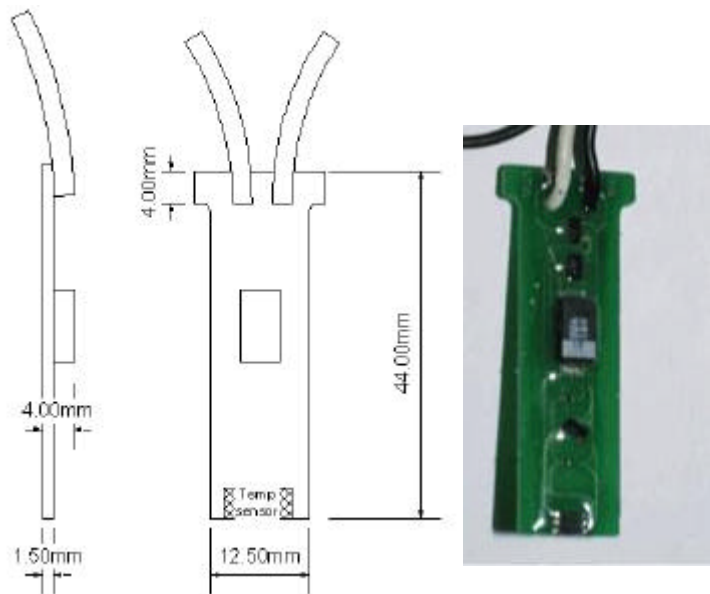
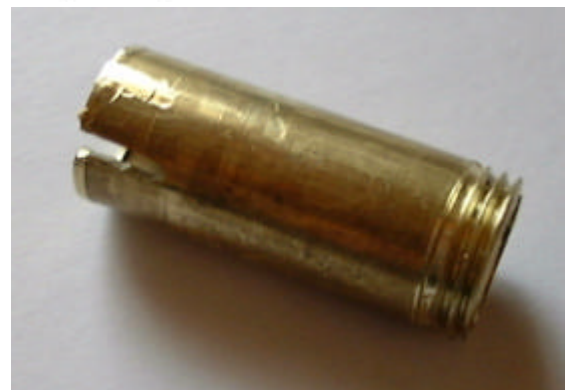
As the sensor PCB was designed to fit into the 1/2" inside diameter pipe of the FM turbo intercooler exit, I used a short piece (about 35 mm) of 1/2" ID brass tubing.

I cut a few M16 threads on the pipe, which helped to give it some mechanical stability when mounted into the thin steel of the crossover tube, and used a Dremel tool to cut some grooves in the other end of the pipe to take the "lugs" of the temperature sensor PCB.

These were then deepened until the business end of the temperature sensor protruded about 10mm out of the other end of the pipe into the airflow. Building a "dummy" temp sensor cut out of thick cardboard for trial fitting helped a lot when prototyping.

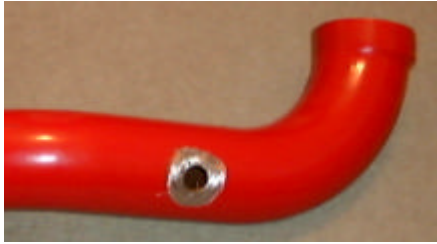
Fixing the tube to the crossover pipe

The next step was to cut a 16mm hole in the crossover pipe. The hole was positioned so that the temperature sensor would protrude from the bottom of the pipe just before the 90 degree bend going into the dummy throttle body.

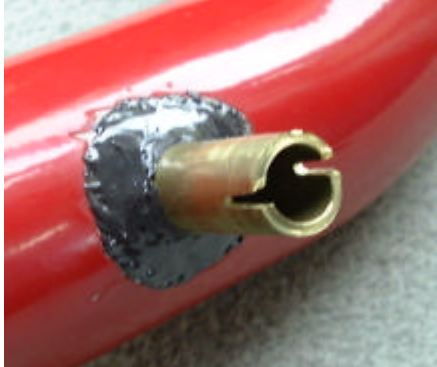
I found that a conical (variable diameter) hole-cutting drill was ideal, as it let me cut the hole just big enough to thread the brass tube in. The threads then held the tube firm while the epoxy set and acted as a sealant & additional mechanical support. Remember to thoroughly clean all the swarf from the inside of the crossover pipe!

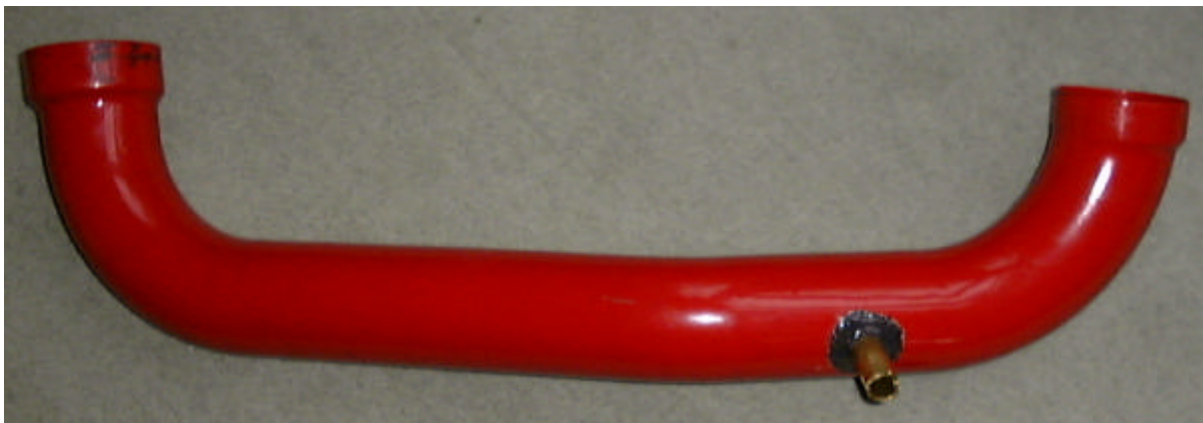
The slots in the pipe were aligned to ensure that the temperature sensor was "in line" with the airflow along the tube, rather than causing turbulence.

To minimise the possibility of the epoxy dribbling through into the crossover tube, a piece of rag was stuffed in behind the tube.

The epoxy was then applied, and left for 24 hours for it to thoroughly set.

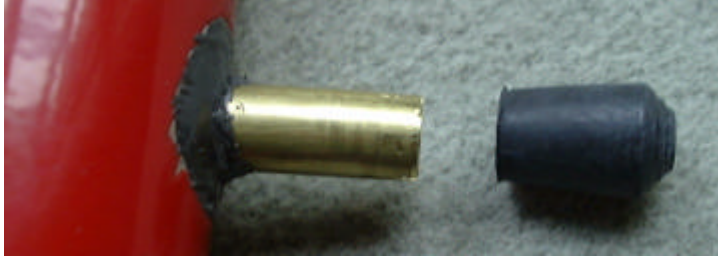
Sealing the open end of the pipe

I managed to find a suitable rubber cap in the local DIY shop – a 16mm walking stick end, which fitted the tube perfectly.

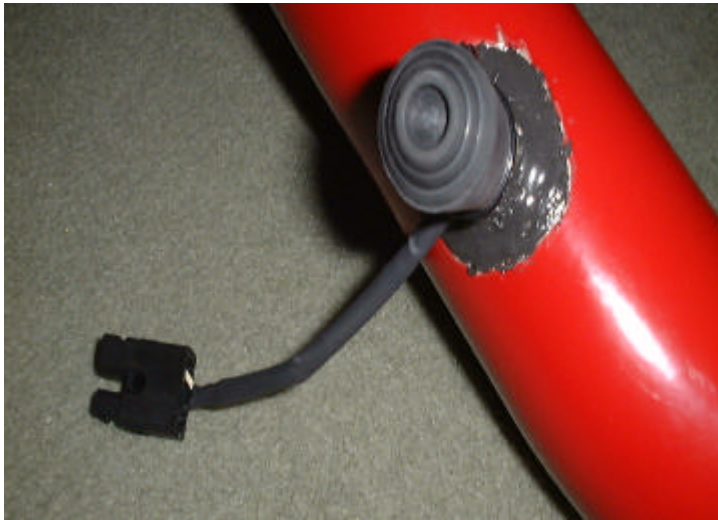
My first attempt routed the two wires back down the side of the tube to avoid piercing the cap. A tie-wrap was then used to stop the cap flying off under boost. In the photo, you can also see the 2-way connector that I used to connect the sensor to the wiring harness – as the crossover tube seems to get regularly removed, I wanted to be able to easily connect and disconnect the temperature sensor.

Having fitted the pipe, I found it difficult to get a stable idle (although the idle MAP readings were pretty much the same as before, the IAC% was close to zero. Interestingly enough, boost wasn't significantly affected. I suspected an air leak down the side of the pipe, where the wires exited the cap.
